Providing Safe Schools for Our Students

Timothy J. Walsh

October 25, 2011

WASHINGTON STATE SCHOOL SEISMIC SAFETY PILOT PROJECT— Providing Safe Schools for Our Students

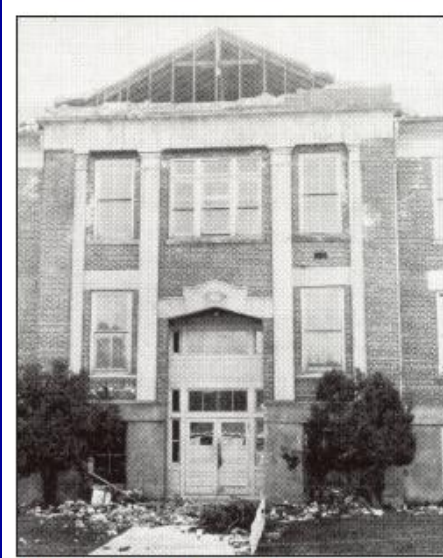
Figure 2. At Castle Rock, a high school student was killed as unanchored gable masonry cascaded to the walk outside the entrance. There could have been more casualties. (From Edwards, 1951.)

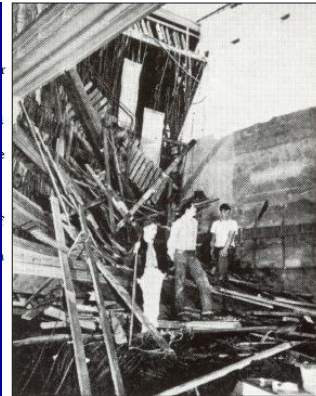
Figure 1. Open air theatre—Three members of the stage crew at Puyallup High School survey the wreckage of the stage, which was caved in by the earthquake just as they were leaving for lunch. Under the debris are a ping-pong table and a grand piano. Seattle Times staff photo by Larry Dion (from Ulrich, 1949).

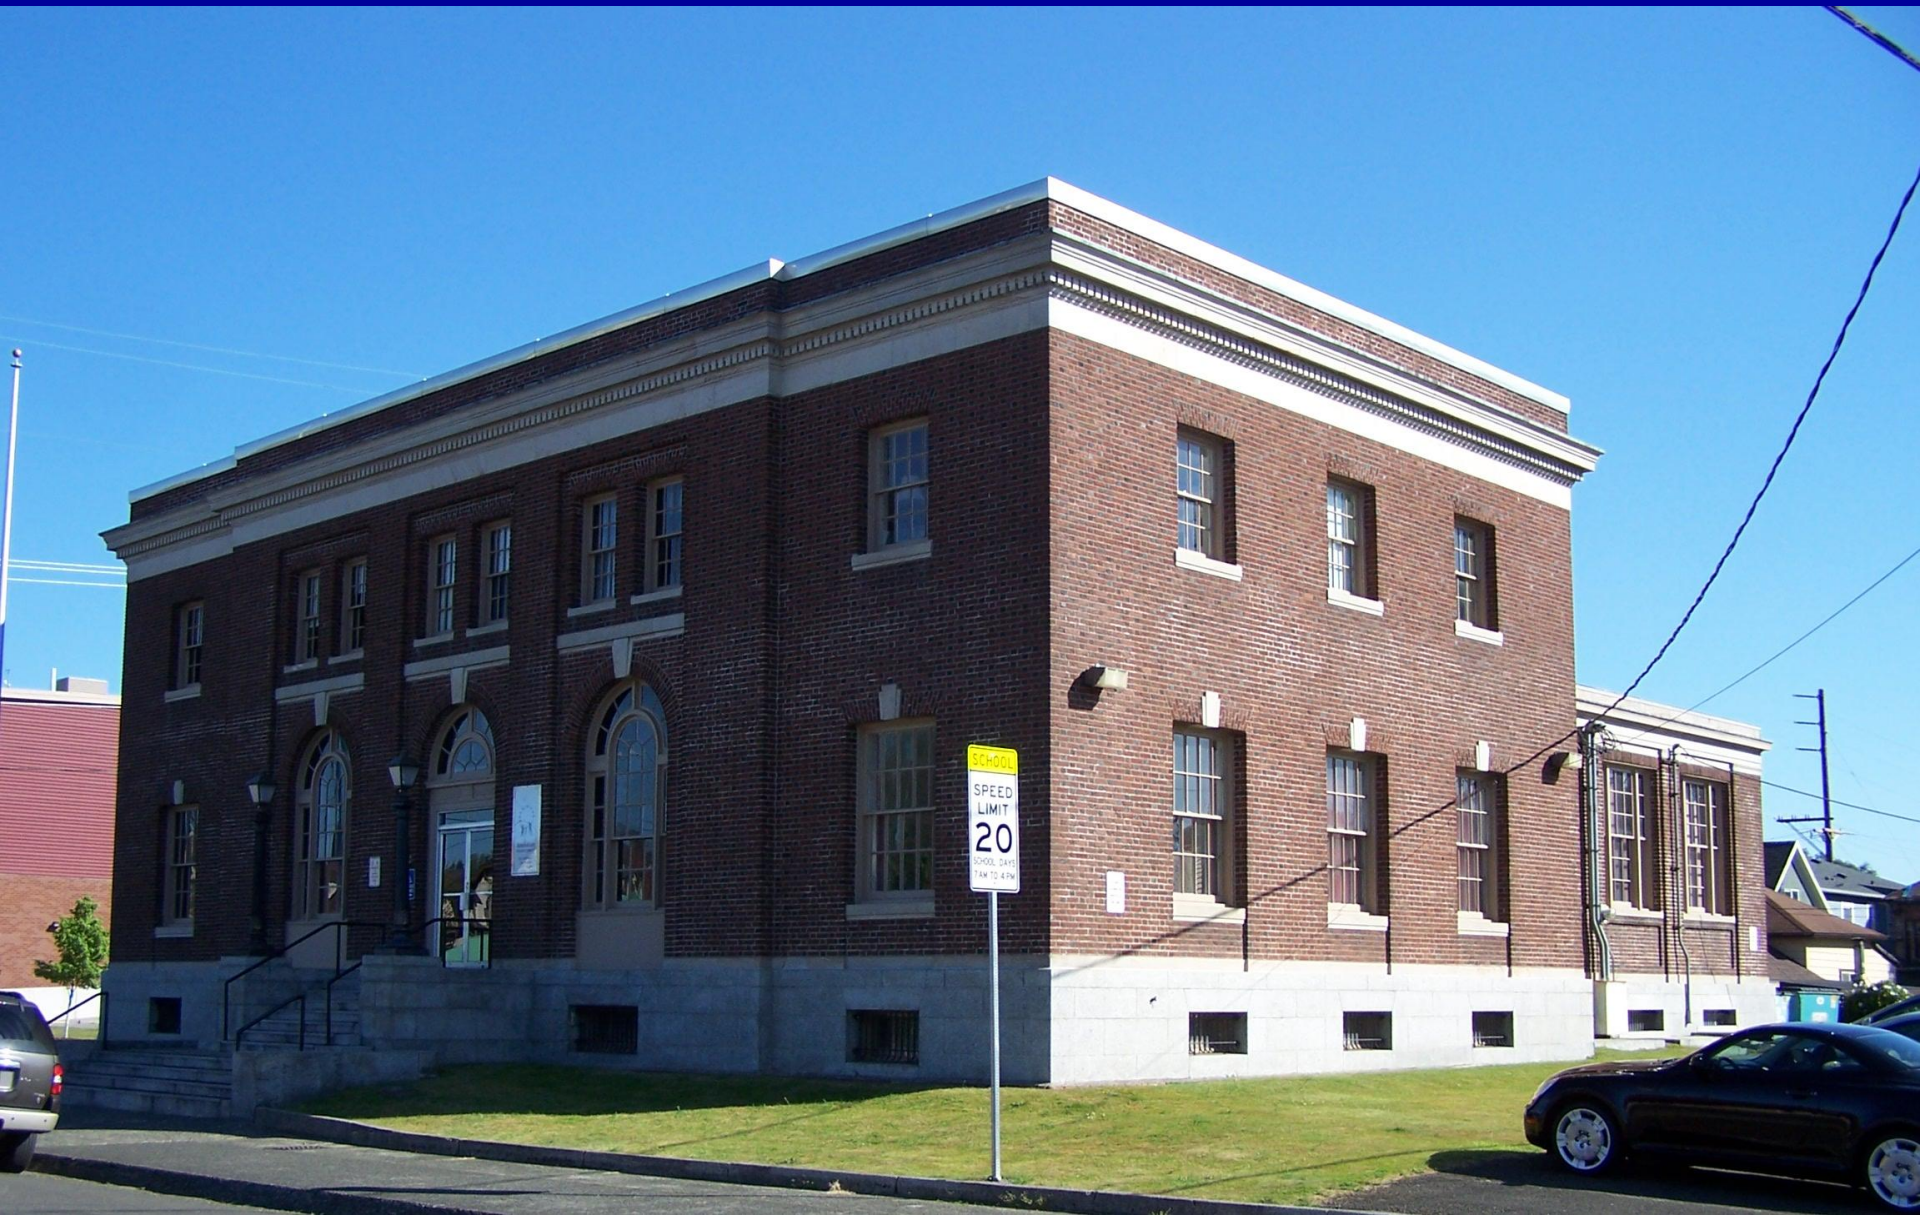
Aberdeen administration building

| C | NC | N/A | | | Comments |
|---|---|---|---|--|---|
| <input type="checkbox"/> | <input checked="" type="checkbox"/> | <input type="checkbox"/> | 4.3.2.1 | WEAK STORY: The strength of the lateral-force-resisting system in any story shall not be less than 80% of the strength in an adjacent story, above or below, for Life-Safety and Immediate Occupancy. | Top Flr, N-S Direction, Approx 66% of 1 st Flr |
| <input type="checkbox"/> | <input checked="" type="checkbox"/> | <input type="checkbox"/> | 4.3.2.2 | SOFT STORY: The stiffness of the lateral-force-resisting system in any story shall not be less than 70% of the lateral-force-resisting system stiffness in an adjacent story above or below, or less than 80% of the average lateral-force-resisting system stiffness of the three stories above or below for Life Safety and Immediate Occupancy. | 1 st Flr, E-W Direction, Approx 44% of Top Flr |
| <input type="checkbox"/> | <input checked="" type="checkbox"/> | <input type="checkbox"/> | 4.3.2.3 | GEOMETRY: There shall be no changes in horizontal dimension of the lateral-force-resisting system of more than 30% in a story relative to adjacent stories for Life Safety and Immediate Occupancy, excluding one-story penthouses and mezzanines. | Lower portion of building is > 30% length of upper portion. |
| <input type="checkbox"/> | <input checked="" type="checkbox"/> | <input type="checkbox"/> | 4.3.2.5 | MASS: There shall be no change in effective mass of more than 50% from one story to the next for Life Safety and Immediate Occupancy. Light roofs, penthouses and mezzanines need not be considered. | Roof Approx 30% Wt of combined 2 nd Flr/Lower Bldg Roof. |

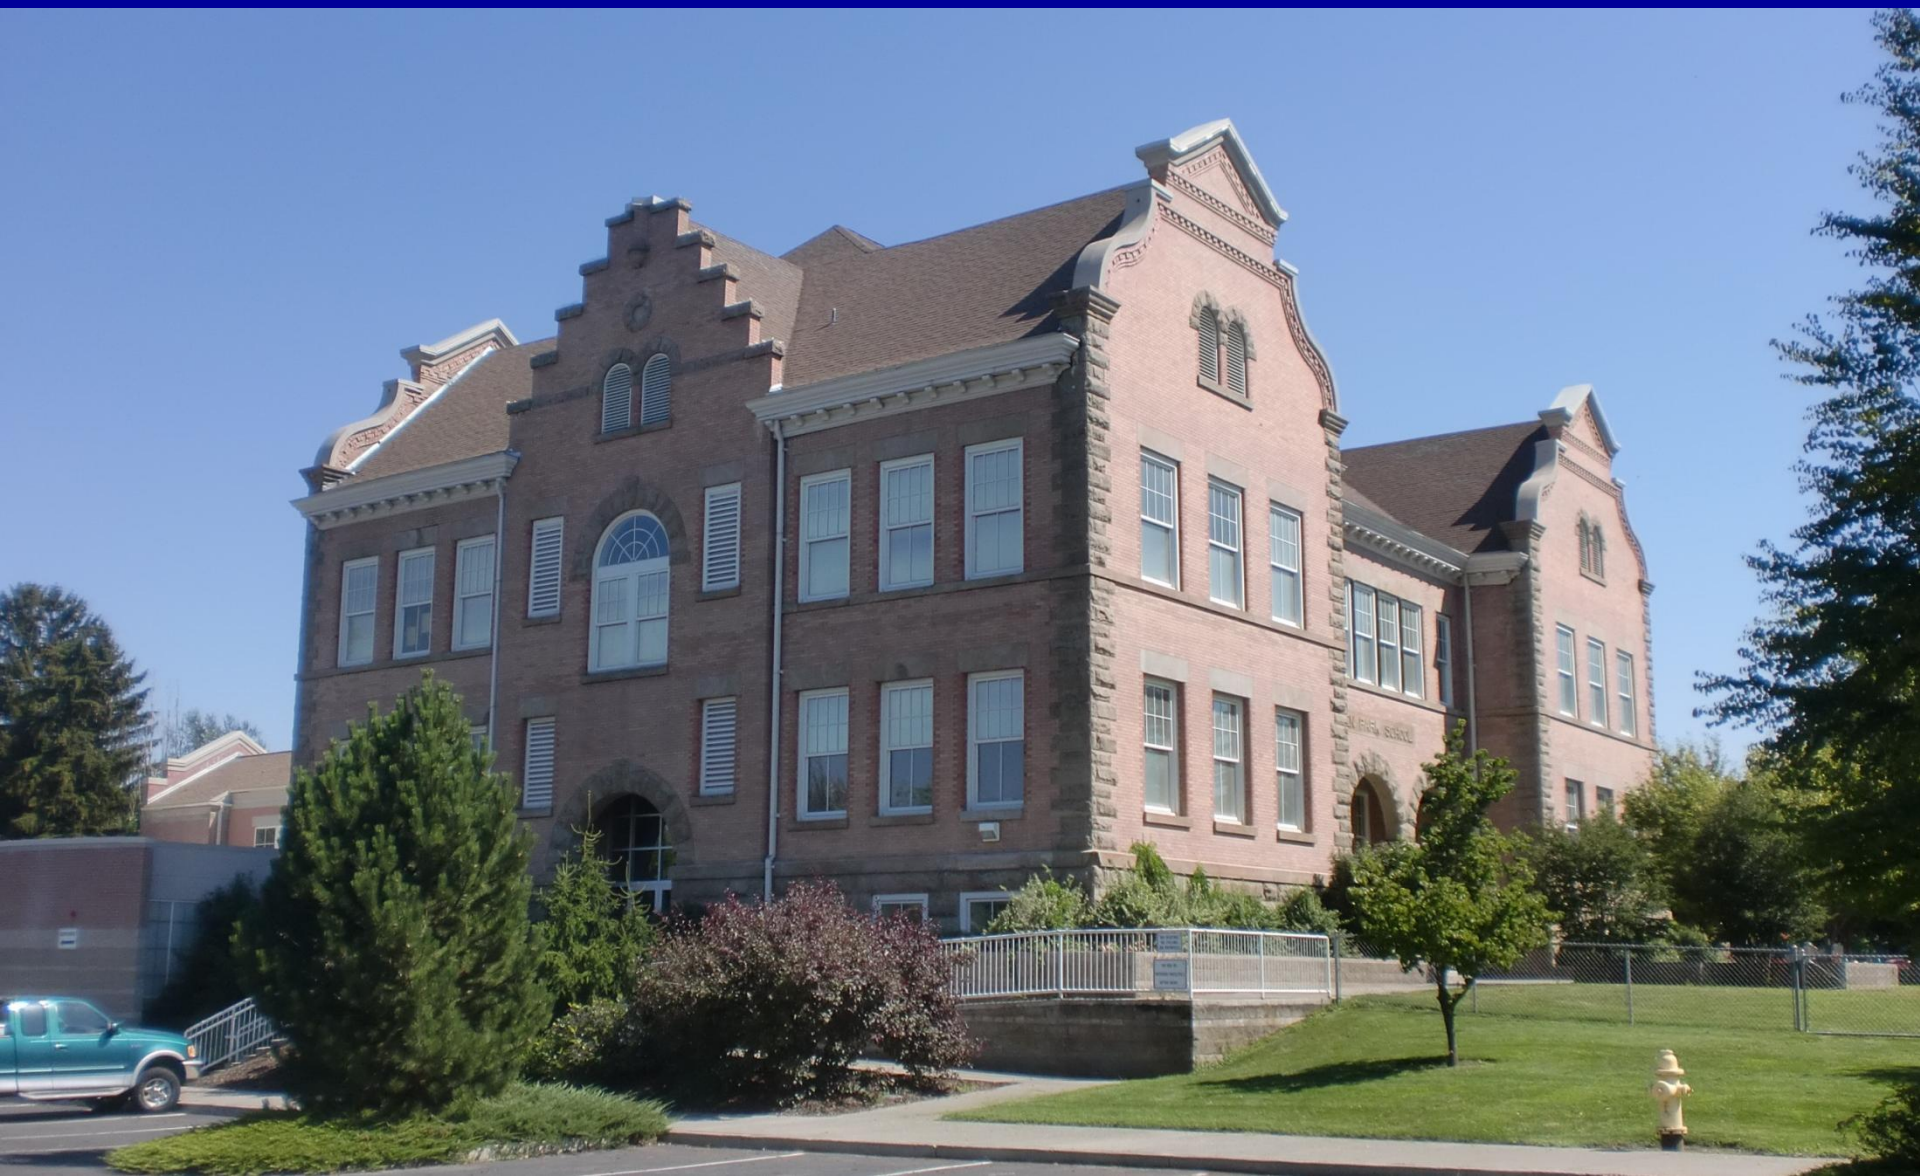
Green Park Elementary

| C | NC | N/A | | Comments |
|---|---|---|---|--|
| <input type="checkbox"/> | <input checked="" type="checkbox"/> | <input type="checkbox"/> | 4.3.1.2 | ADJACENT BUILDINGS: The clear distance between the building being evaluated and any adjacent building shall be greater than 4% of the height of the shorter building for Life Safety and Immediate Occupancy. 2" seismic joint provided. Attic is 44.5 ft AFF, requiring a 21" seismic separation. |

| C | NC | N/A | | Comments |
|---|---|---|---|---|
| <input type="checkbox"/> | <input checked="" type="checkbox"/> | <input type="checkbox"/> | 4.6.1.1 | WALL ANCHORAGE: Exterior concrete or masonry walls, that are dependent on the diaphragm for lateral support, shall be anchored for out-of-plane forces at each diaphragm level with steel anchors, reinforcing dowels, or straps that are developed into the diaphragm. Connections shall have adequate strength to resist the connection force calculated in the Quick Check Procedure of Section 3.5.3.7. |
